Portland Works, Sheffield, South Yorkshire

Conservation Plan
Volume 2

Ref: 100880.02
December 2013

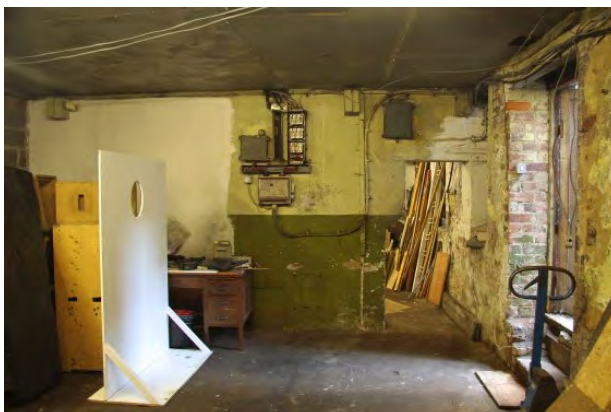
IMG_2010

Layout/circulation/access	This room was originally a single space, rectangular in plan, with external access to the north and internal access with basement 4, Block D. The once single room has been sub-divided using modern brick partitions, into three rooms. Alterations to the lightwells and access to the north was likely after the addition the phase 6 extension. The internal layout and access was also likely altered during WW2 when the space was utilised as an air raid shelter.	3
Wall	All external structural walls are a mix of hand-made red brick and sandstone, internally painted. Modern partitions are built using a modern machine-made brick. The easternmost room contains a paint scheme of a green lower half, and white upper half – fairly typical of industrial working spaces. The remainder of the rooms were painted white.	4
Ceiling	The ceiling is a lath and plaster construction, painted white. Large areas of plaster are missing, exposing the laths beneath. Oil from former machinery within the room above has penetrated the ceiling structure, saturating it.	4

Floor	The floor is a concrete surface throughout - likely original.	4
Windows	All lightwells along the south side have been blocked, although some original timber casements have been retained. These appear to be in a fairly poor condition however. The same goes for those to the north, however, one window towards the west end of the space has been converted to a doorway, leading from the space below the later extension. All fenestration has bull-nosed brick jambs.	3

The basement space has lost some of its original character, which was once used as a silversmiths workshop, by its sub-division and blocking of the lightwells. However, its sub-division may be related to the later use as an air raid shelter for the works - an important part of its history. Reinstatement of the windows/lightwells would be greatly beneficial, adding aesthetic and evidential value to the space.

Currently the space is used as a store. No heating or natural light. The current condition survey suggests the full blocking and capping of the lightwells. This would be detrimental to the character of the space. Reinstatement would add to the aesthetic and evidential value of the space.
