# Portland Works, Sheffield, South Yorkshire

Conservation Plan  
Volume 1

Ref: 100880.02  
March 2014

**Conservation Plan  
Sections 1-3**

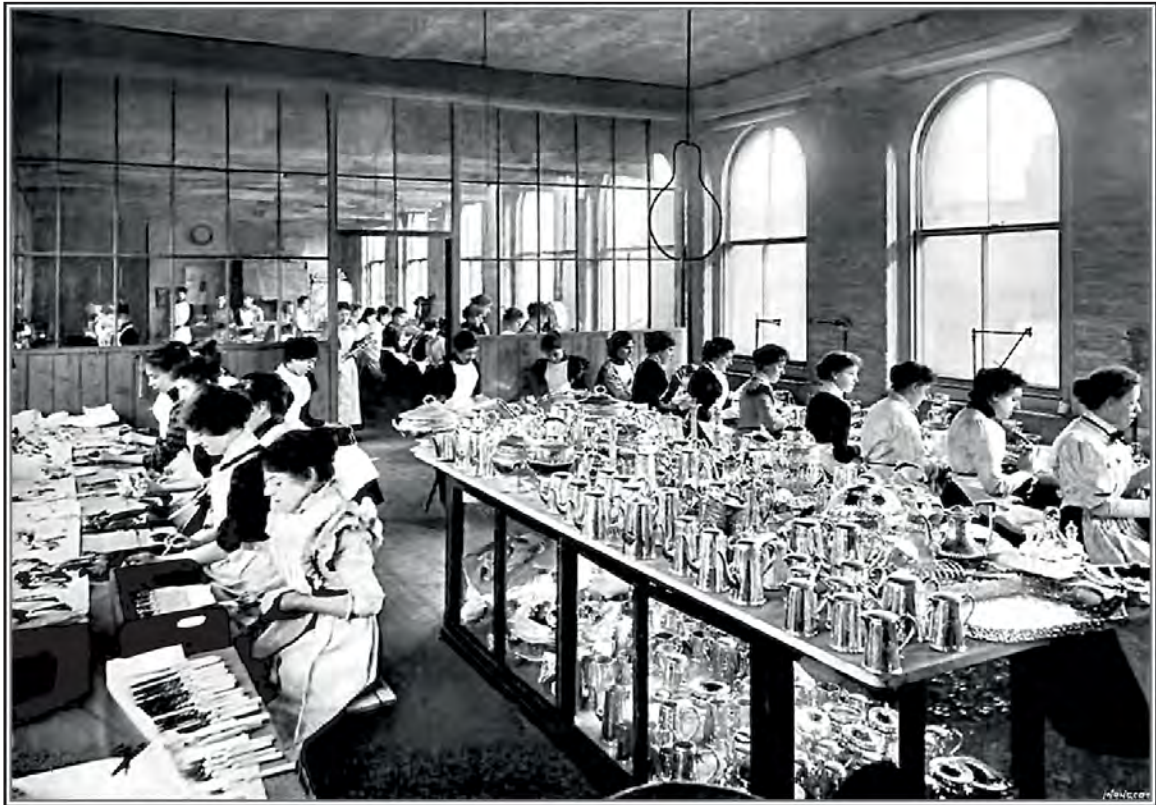
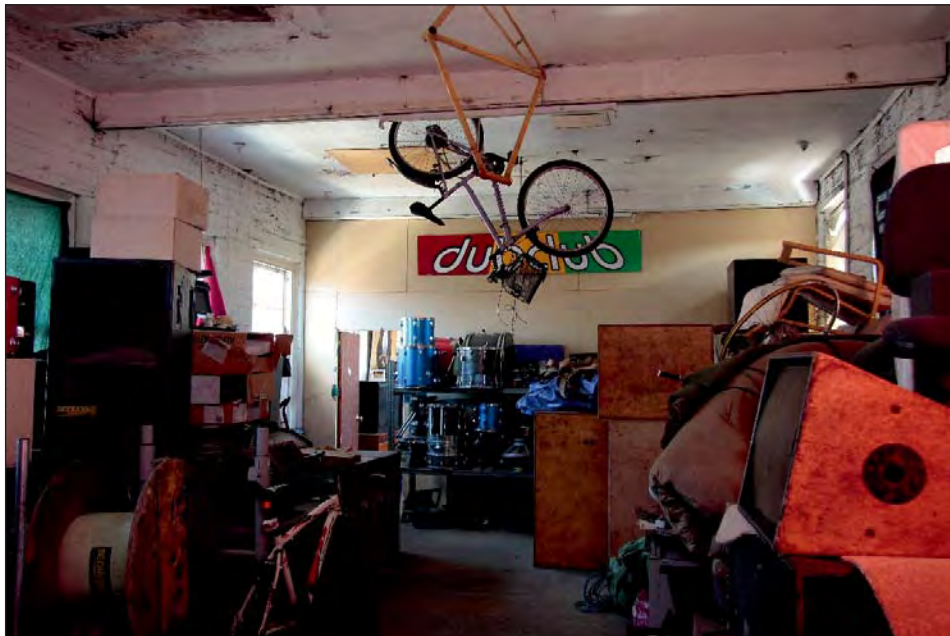
Burnishing and Polishing, 1908, Block A 1.18 (courtesy of Professor G. Tweeddale and H. Housley)

Block A 1.18, 2013

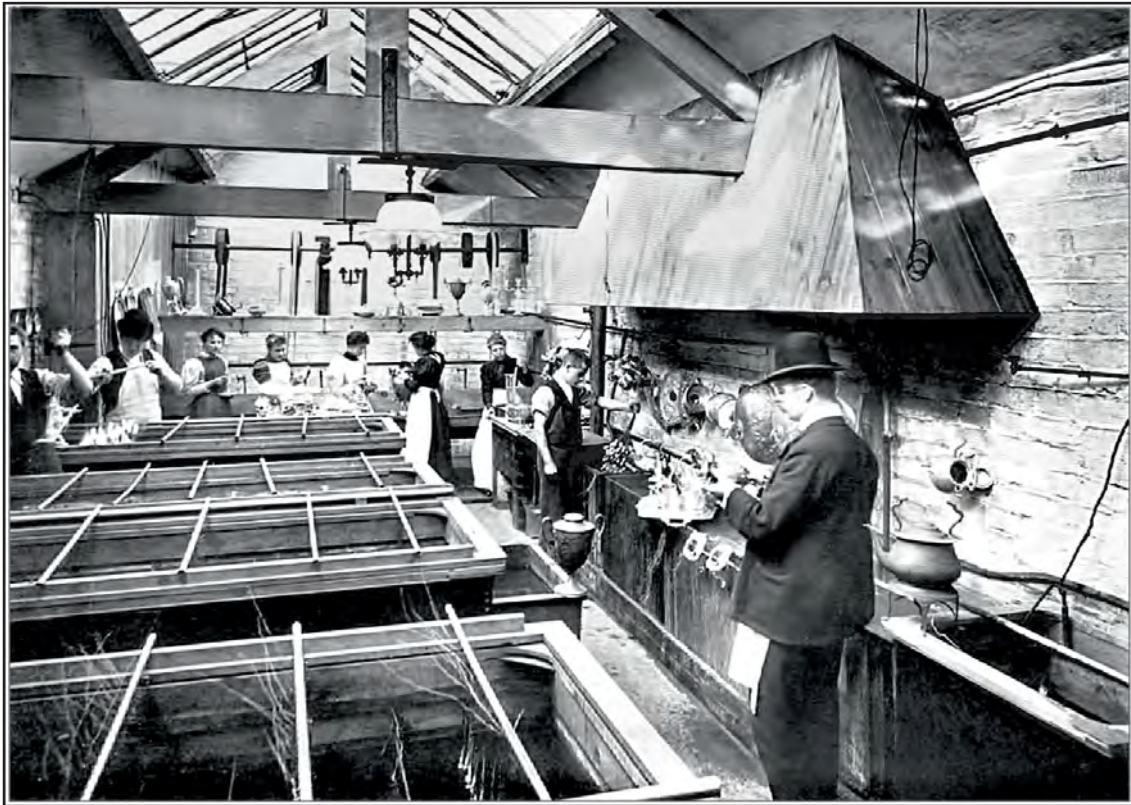
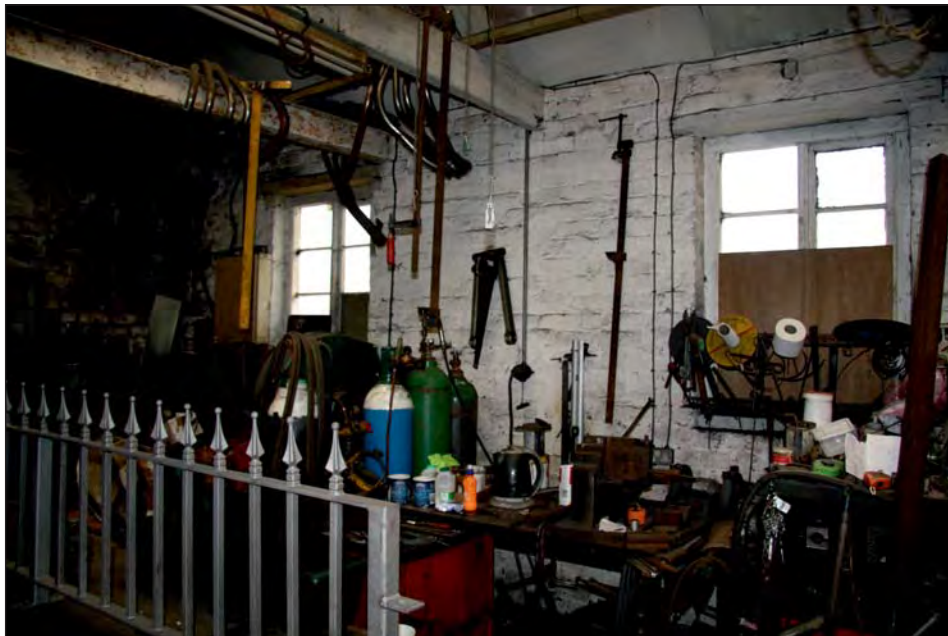
Electroplating, 1908, Block F 1.39 (courtesy of Professor G. Tweedale and H. Housley)

Block F 1.39, 2013

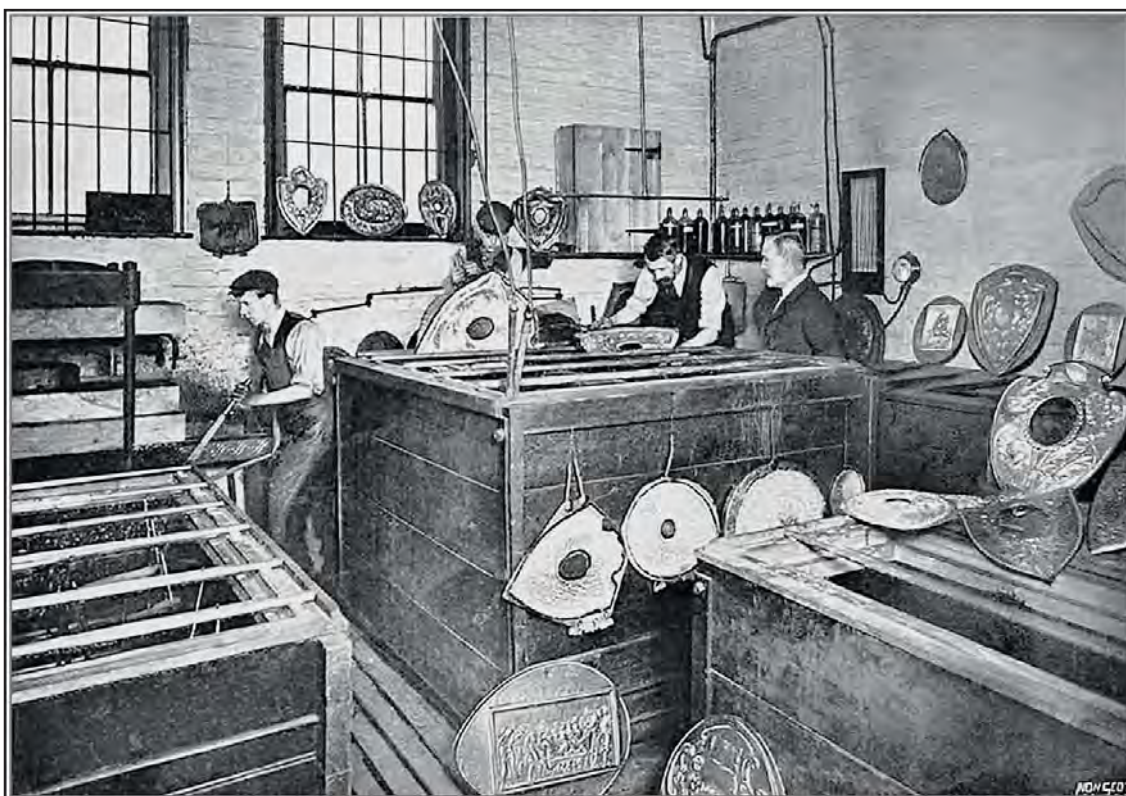
Electroplating, 1908, Block A 1.5 (courtesy of Professor G. Tweedale and H. Housley)

Block A 1.5, 2013

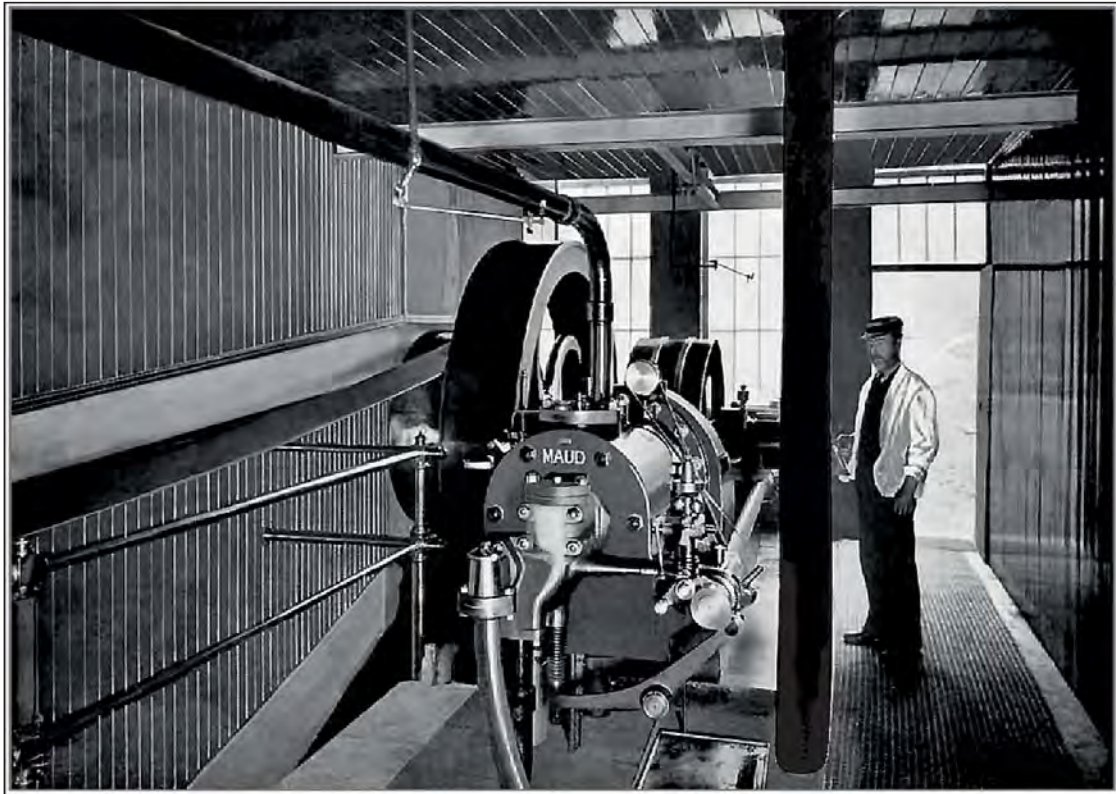
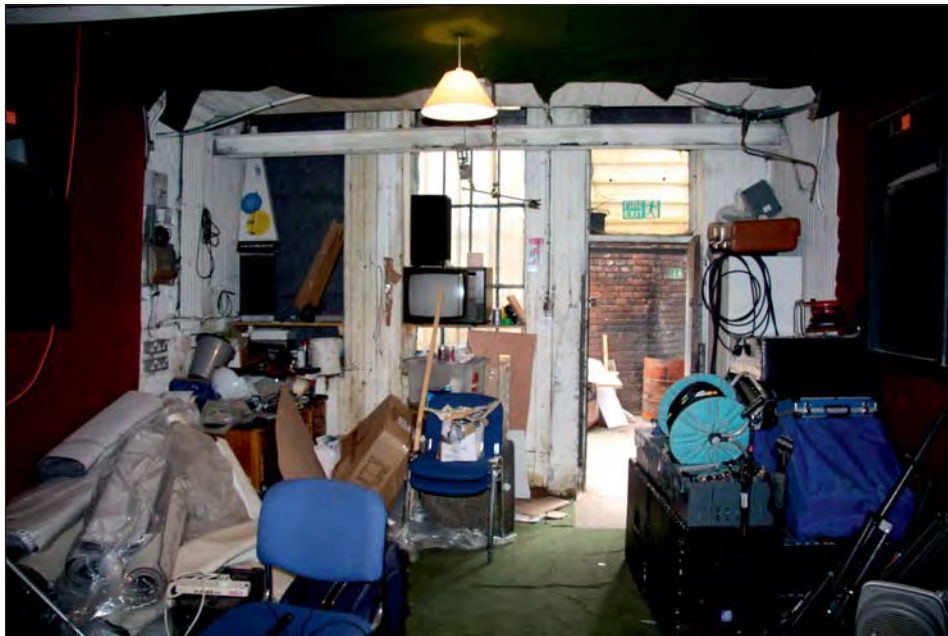
Gas Engine, 1908, Block C 1.23 (courtesy of Professor G. Tweedale and H. Housley)

Block C 1.23, 2013

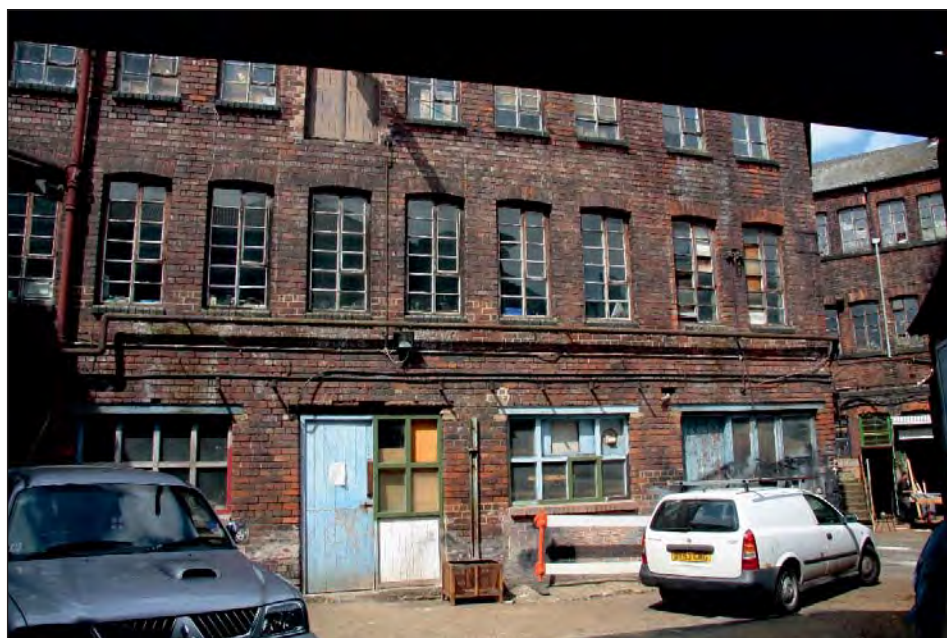
Hand Forges, 1908, Block B 1.19 (courtesy of Professor G. Tweedale and H. Housley)

Block B 1.19, 2013

- 3.2.7 Integrated works also usually housed hand forges which were small individual units, each with independent access from the yard and their own hearths. A commonly found feature is the presence of a timber stable door with adjoining casement window, sharing a common timber frame beneath a single lintel. At Portland Works these are present on the ground floor of the western workshop range, **Block B** (1.19) and along the west side of the central range, **Block G** (1.34 and 1.36). However, evidence provided by historic photographs dating to 1908 shows that the hand forge doorways and adjacent windows were originally open, with the stable door and casement window added later. Inside each of these hand forges there would have been a hearth, bellows and anvil. None of these have been retained at Portland Works, although their general arrangement and a selection of historic doors and windows are in situ (**Figure 12**).

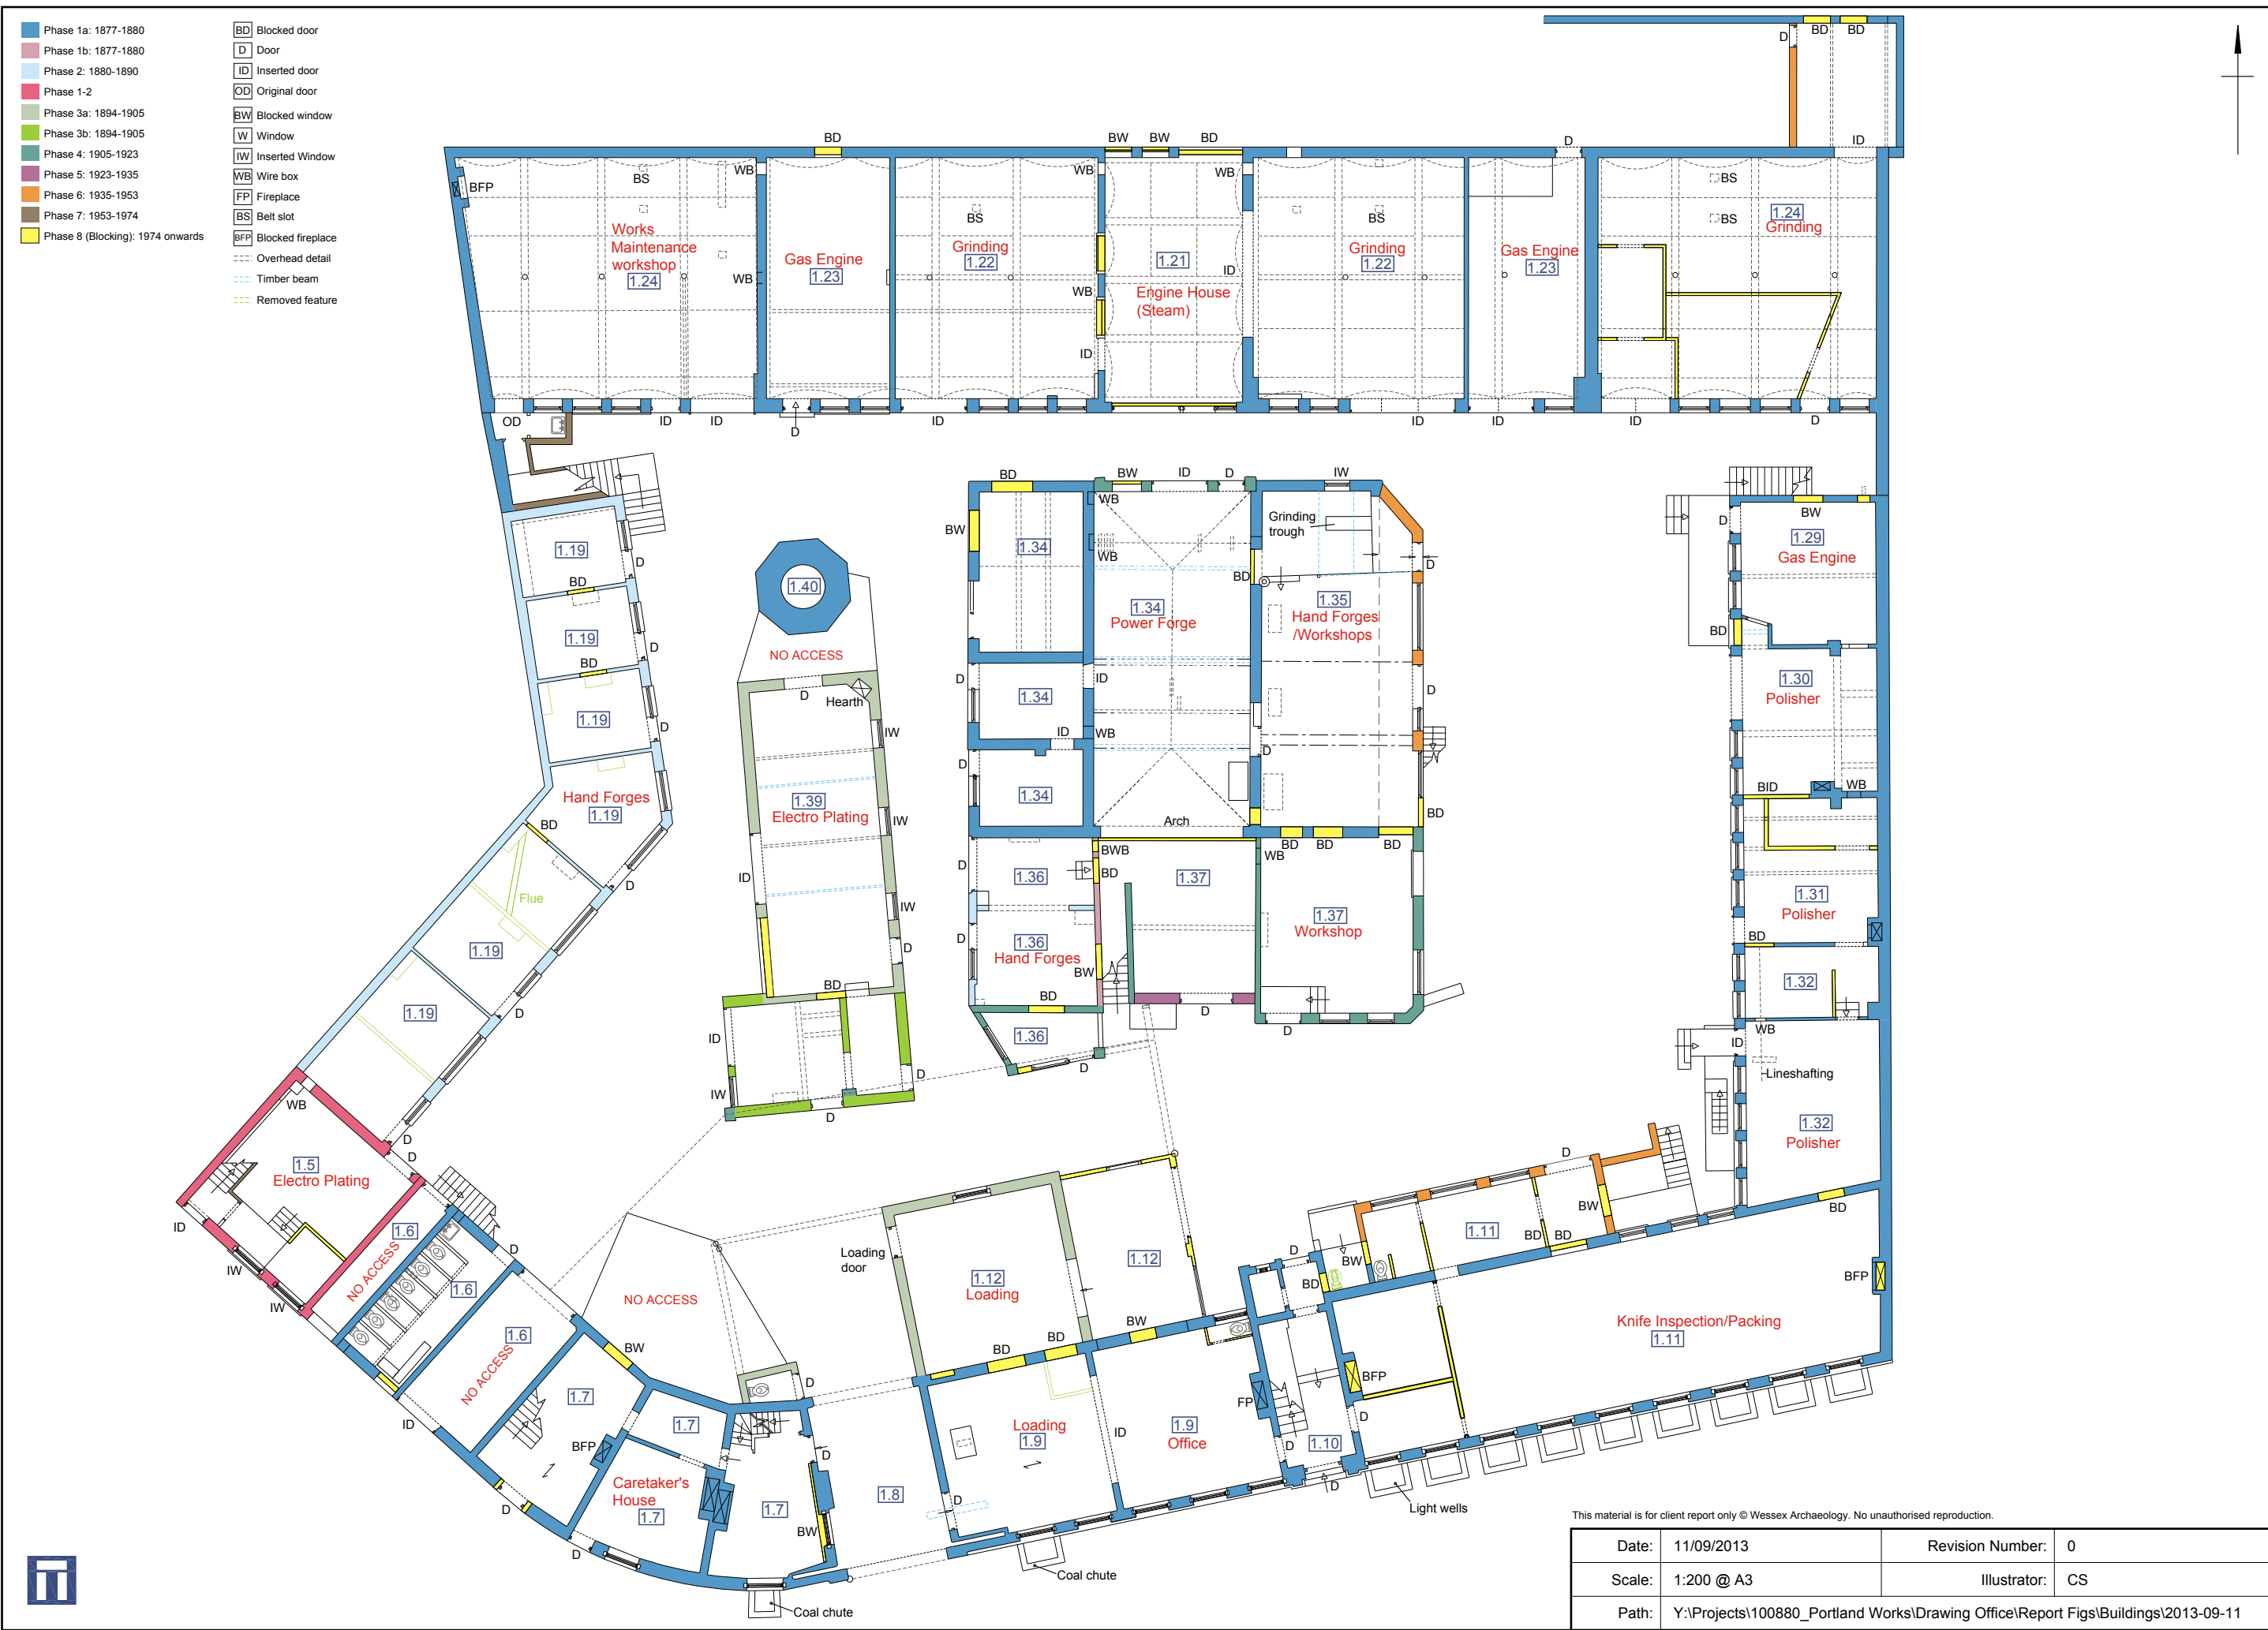
Figure 18

Phased ground floor plan

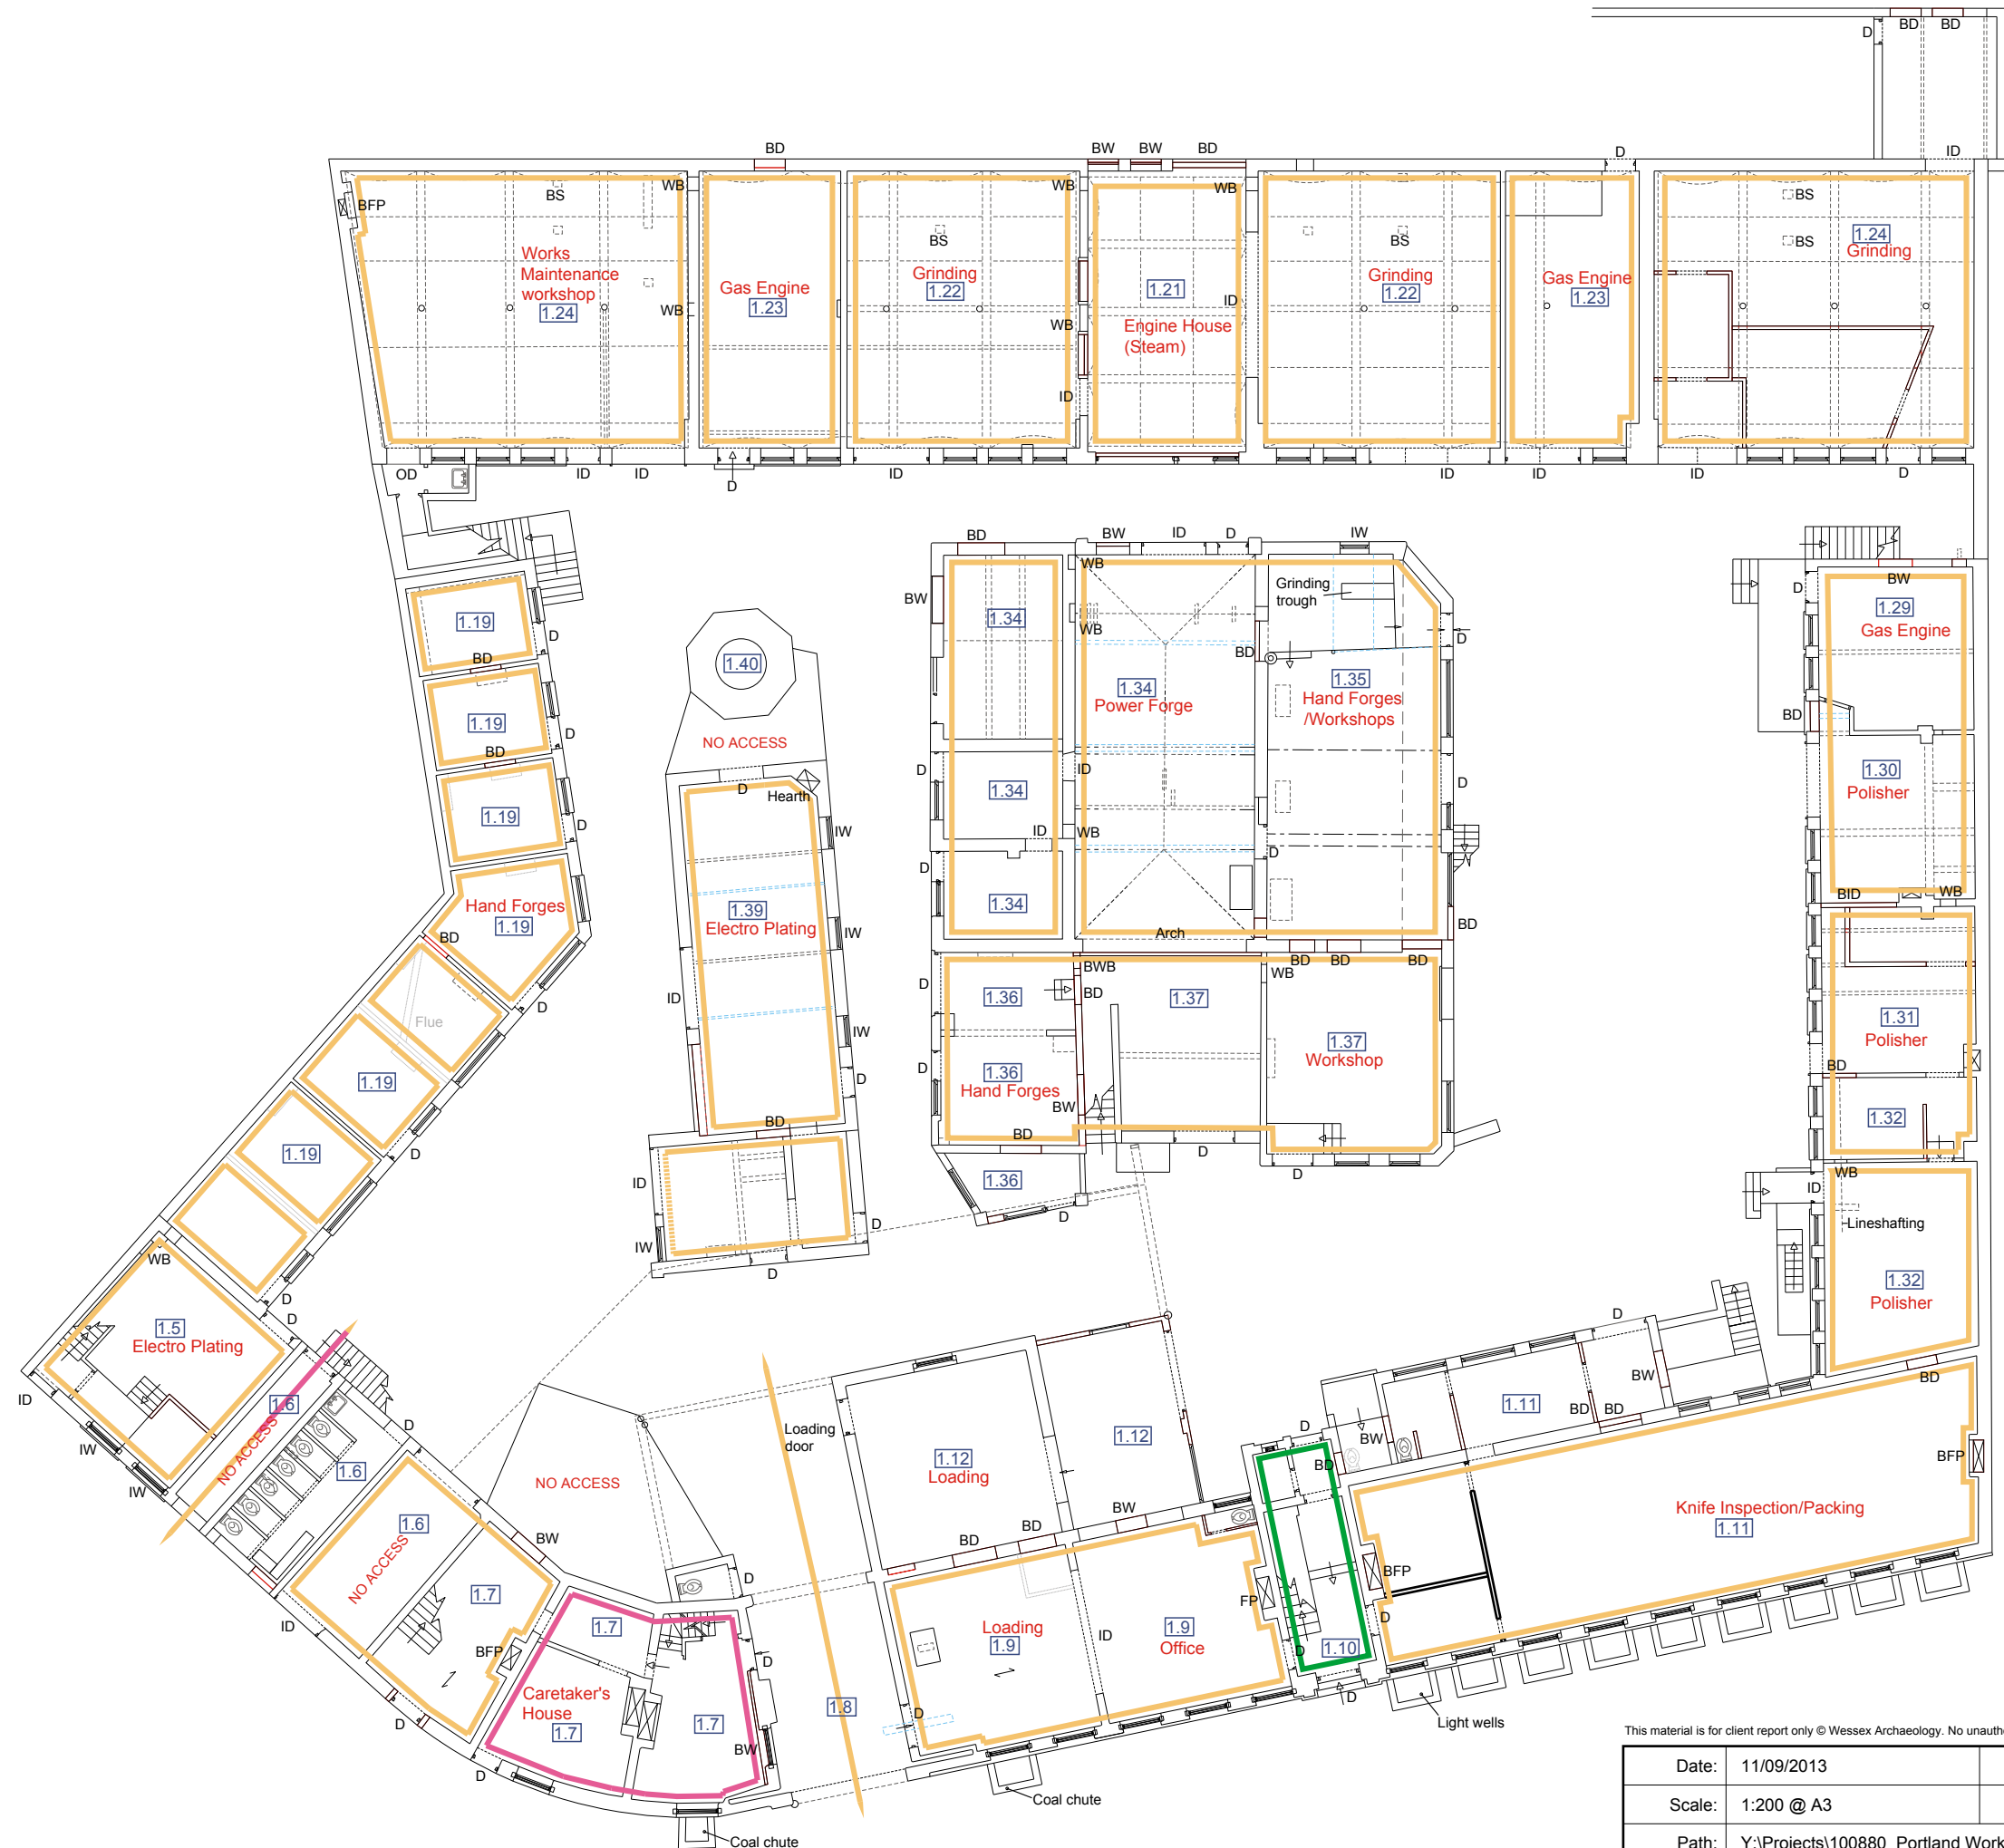
Figure 29

- Public access
- Residential
- Workshop units
