Portland Works, Sheffield, South Yorkshire

Conservation Plan
Volume 2

Ref: 100880.02
December 2013

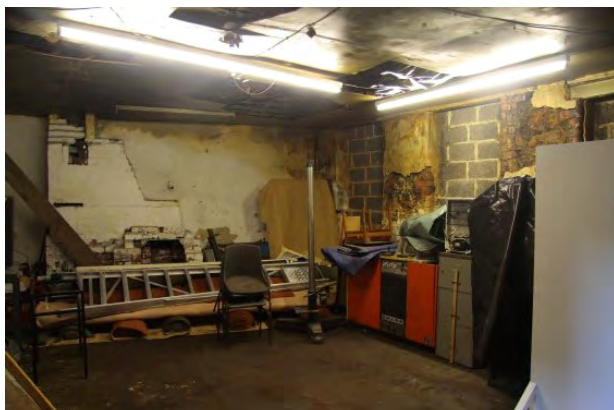
Block A - Basement 1**1.1**

Layout/circulation/access	This room was originally a single space, rectangular in plan, with external access to the north and internal access with basement 4, Block D. The once single room has been sub-divided using modern brick partitions, into three rooms. Alterations to the lightwells and access to the north was likely after the addition the phase 6 extension. The internal layout and access was also likely altered during WW2 when the space was utilised as an air raid shelter.	3
Wall	All external structural walls are a mix of hand-made red brick and sandstone, internally painted. Modern partitions are built using a modern machine-made brick. The easternmost room contains a paint scheme of a green lower half, and white upper half – fairly typical of industrial working spaces. The remainder of the rooms were painted white.	4
Ceiling	The ceiling is a lath and plaster construction, painted white. Large areas of plaster are missing, exposing the laths beneath. Oil from former machinery within the room above has penetrated the ceiling structure, saturating it.	4

Floor	The floor is a concrete surface throughout - likely original.	4
Windows	All lightwells along the south side have been blocked, although some original timber casements have been retained. These appear to be in a fairly poor condition however. The same goes for those to the north, however, one window towards the west end of the space has been converted to a doorway, leading from the space below the later extension. All fenestration has bull-nosed brick jambs.	3

Doors	Original doorway to the north, providing external access has been widened, and double doors attached. – possibly when the space was used as an air raid shelter so that more people could get in as quickly as possible. At the eastern end of the room, an original doorway opening (no door) provides access to the adjacent room (basement 4, Block D). This has been partially blocked with blockwork. At the western end, a former window has been converted to a doorway to provide secondary pedestrian access from beneath the phase 6 extension to the north. All original doorway openings have bull-nosed brick jambs.	2
Fixtures and fittings	Few fixtures or fittings retained. Inserted overhead timber beams were within sub-divided rooms.	5
Power	No power observed.	1
Heating	Large brick built fireplace is present at the east end of the space. There is also a chimney stack with either blocked fireplace or inserted flue at the west end (not fully observed).	4

Currently the space is used as a store. No heating or natural light. The current condition survey suggests the full blocking and capping of the lightwells. This would be detrimental to the character of the space. Reinstatement would add to the aesthetic and evidential value of the space.

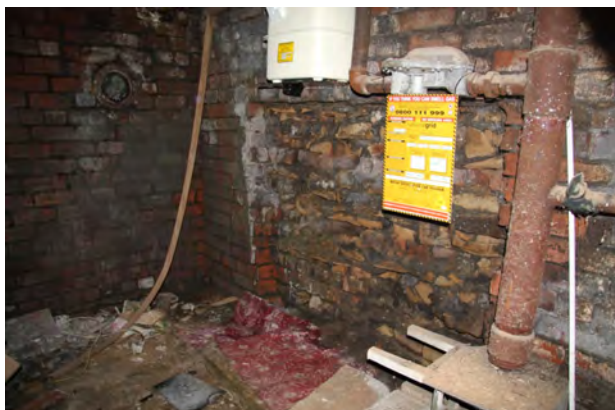
1.2

Currently the space has no heating, or lighting and is damp. The room is currently used as a 'store'. Clearance and full inspection is required.

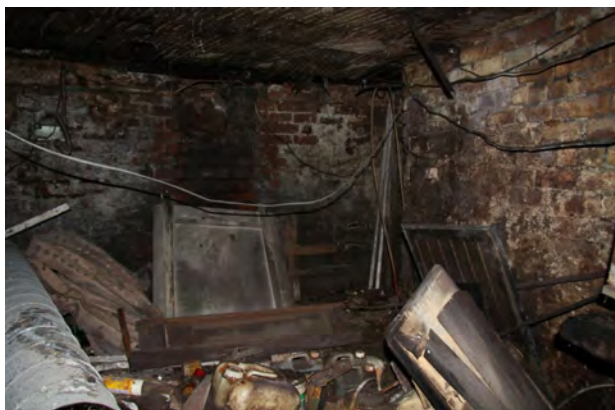
Block A - Basement 3**1.3**

The room is currently used as a store and is fairly damp. There is no heating or natural lighting. The space requires clearance and inspection.

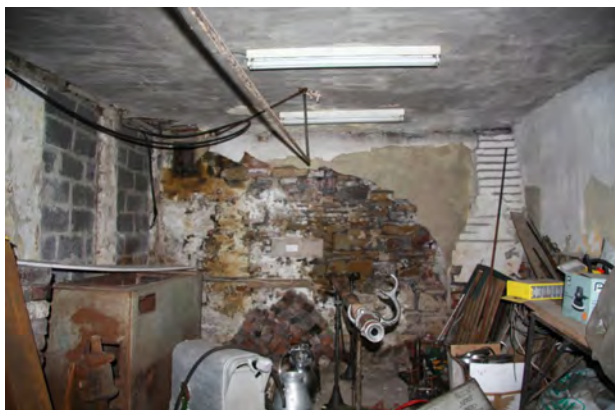
1.4

The ceiling is painted lath and plaster. Some patches of plaster missing.

Currently the room is used for storage, but has damp problems. Better access, natural light and heating are need for this to be used for anything other than storage. The reinstatement of the lightwells/windows would be beneficial to the space, adding to the aesthetic and evidential value of the space.

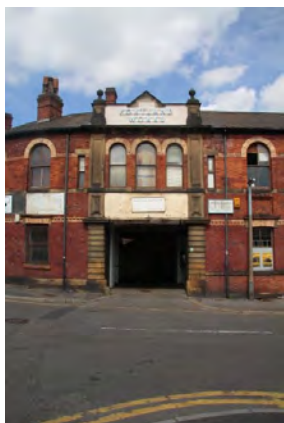
Stone setts with later coverings of tarmac (worn).

Fixtures and fittings	Modern gates are attached to the southern opening. Large hinges are present on the former northern opening of the cart passage for a second gate into the works. A stone bollard is positioned adjacent to the west pillar of the south façade of the cart passage, protecting the quoins from vehicular damage. In addition, above the doorway in the east wall is a timber beam, continuing internally into the workshop (1.9). In addition, at the northern end, within the ceiling above is a loading door for the floor overhead (1.16/1.14). Fixed on the east wall are tenant post boxes.	4
Power	No power.	5
Heating	No heating.	5

The cart passage is the main entrance to the works and contains the tenants post boxes. The architectural detail of the cart passage opening makes an essential contribution to the special historic character of the works as a whole and needs to be conserved. Removal of later tarmac coverings would be advantageous.

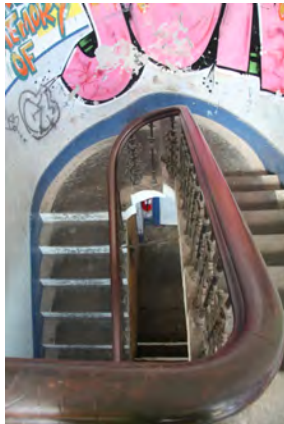
Block A - Ground Floor 6 (Circulation & Toilets)**1.10**

The walls are plastered and painted and contain original high and deep moulded skirting boards, inlaid dado. Detracting from the original character and aesthetic value of the space is graffiti around the northern curved wall of the staircase. Some areas of plaster are also missing in places.

The area is currently a circulation area which provides access to 1.9, 1.10, 1.17 and 1.18, which has original features in need of some attention. The removal of graffiti on the wall of the main staircase would be greatly beneficial to the space, as this currently has a negative impact on the historical character of the space. Replacement of modern doors with in-keeping timber doors, whilst refurbishment of original doors, would be a positive contribution to the aesthetic value of the space.

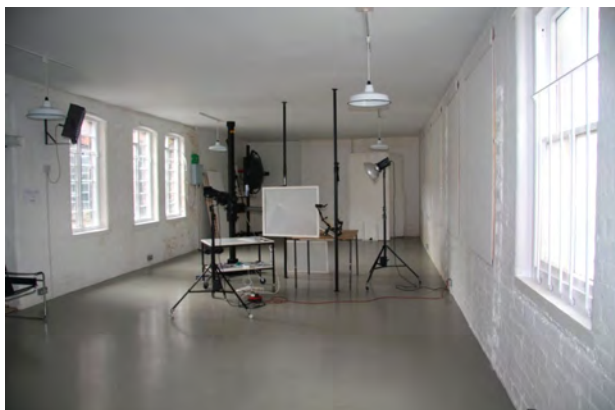
Modern boarding covering timber floor boards (damaged by oil penetration from former machinery since removed).

The south wall of the south room contains 9 original timber sash windows. The north wall of the south room has three original timber casement windows. Metal bars have been added internally in front of all fenestration for security. The north room contains 3 timber casement windows, one of which is a modern replacement. A blocked window is positioned at the east and west ends of the north room also.

The space is currently utilised as a photographic studio with modern finishes and fixtures and fittings throughout the space. Well maintained space. Conservation of retained windows is needed. Conservation of the windows is needed, and possibly replace modern door to the west with one which is more in keeping with the historic character of the space.

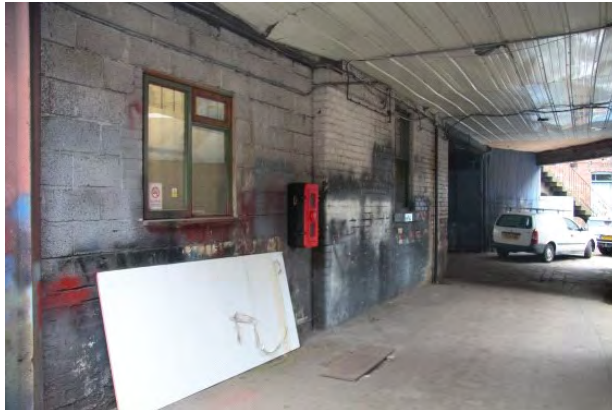
1.12

Currently the space is used as an electrical workshop with few management issues. Externally the walls need attention in terms of water damage and spray paint. This in addition to exposed blockwork is not aesthetically in keeping with the character of the works.

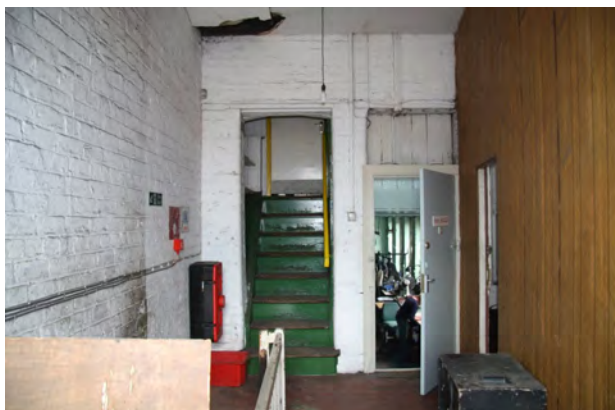
1.13

Painted lath and plaster. Some areas of lath and plaster are missing due to water ingress.

The area is currently used as an office with store and small kitchenette and W.C. with access to the first and second floors of Block B. Damage from water ingress from the roof is prevalent and should be seen as a priority for this area.

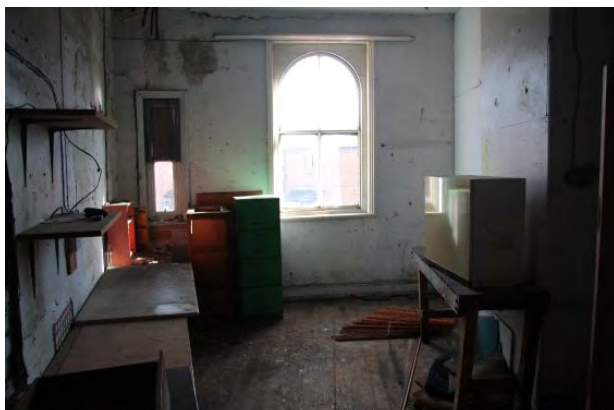
Block A - First Floor 3 (26-1)**1.15**

The space has been left to fall into general disrepair due to former tenancy. The area has been used for general storage and possible residential. The main walls have areas of missing plasterwork and graffiti. The spaces can be refurbished without losing any further historic fabric, fixtures or fittings. Retention of original windows, skirtings, and architraves would contribute to the evidential and aesthetic value of the space.

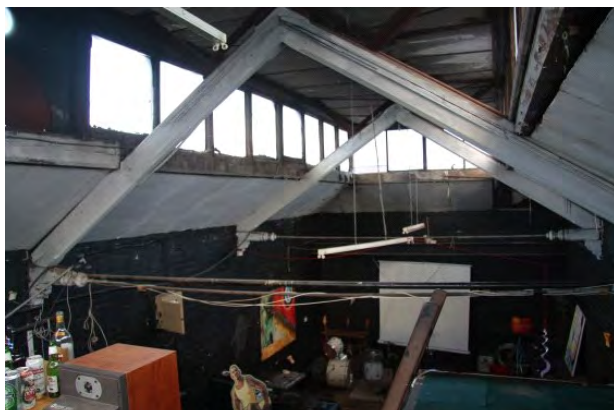
1.16

The ceiling of the space has exposed decorative timber trusses with console brackets and iron tie beams. These support a flat roof above with skylight. This was once one large skylight with pitched and hipped central section. This central section has been removed and replaced with the current flat roof. Modern plasterboards cover the lower pitch of the roof.

The space has most latterly been used as a music studio and general party area. The space would benefit from the removal of the modern room partitions, creating a single room again. The roof is in need of attention as water is filtrating into the room. Reinstatement of the full skylight would add to the historic character of the space.

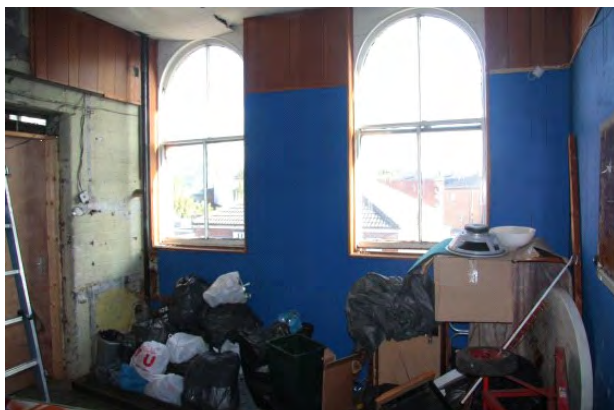
1.17

The space has most recently been utilised for storage which has over taken the space. The area needs clearing, removal of modern partitions and removal of graffiti. Retention and conservation of original windows and architraves would be advantageous for the aesthetic and evidential value of the space.

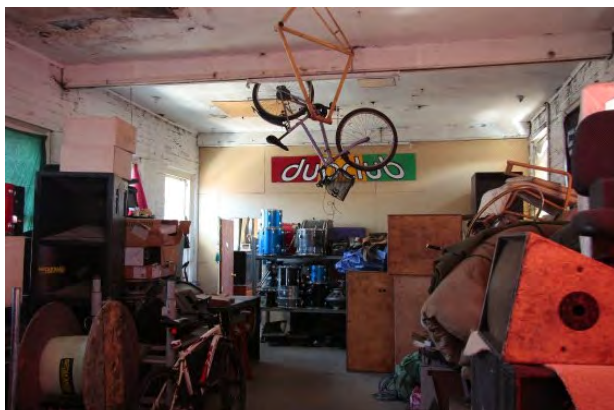
The space is currently utilised as a music equipment store and rehearsal space. Management of the upkeep of the space is required. Restoration of windows and doors, as well as possible restoration of the original timber floor would add value to the space.

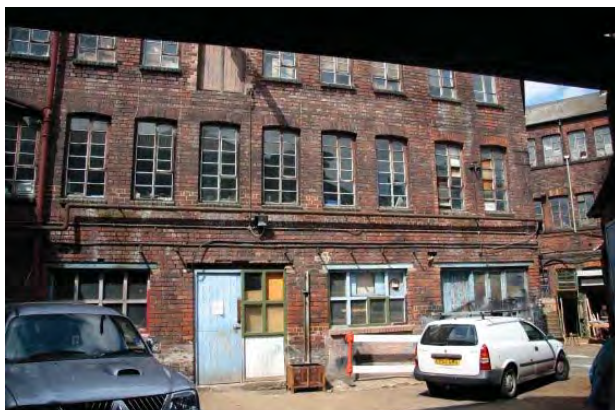
The rooms are currently used as workshop stores. All have electricity, but there is no heating in any of the rooms. Some damp issues are apparent.

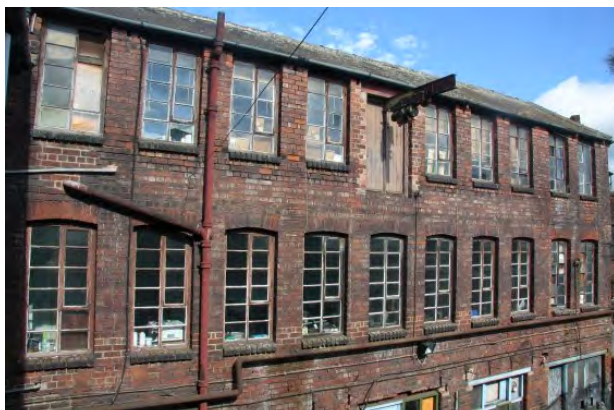
Both floors have painted brick walls and the modern partitions are boarded studs. Water ingress from the roof has caused some damp to the walls.

The first floor is currently used as a workshop whilst the second floor is used by artists and musicians and both are well maintained and need little management. Priority would be to make good the roof, preventing any further water damage.

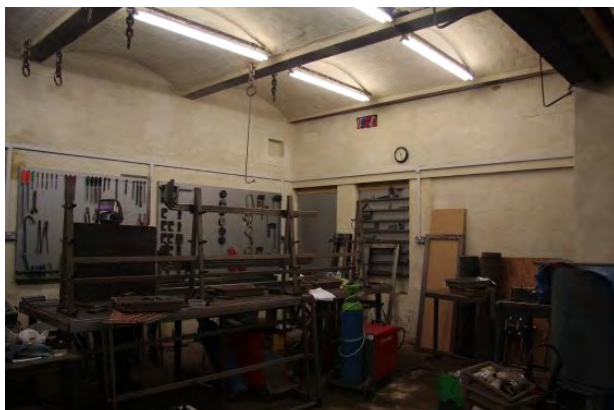
The room is currently used as a workshop and is well maintained. The south wall and openings within it are in need of some attention. The upkeep and retention of the large cast iron bearing boxes in the east wall is of the most importance.

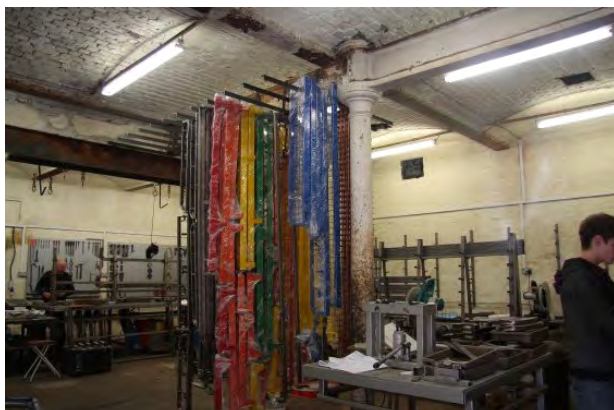
Block C - Ground Floor 2 (6C.2, 7C)**1.22**

The rooms are currently used as a workshop and are fairly well maintained. Structural problems are evident due to the off centred jack-arches which are not properly distributing the weight of the upper floors to the piers of the south wall. This is also exacerbated by the shallow foundations of the south wall. This structural problem is a priority for future management. Historical fixtures and fittings should be retained.

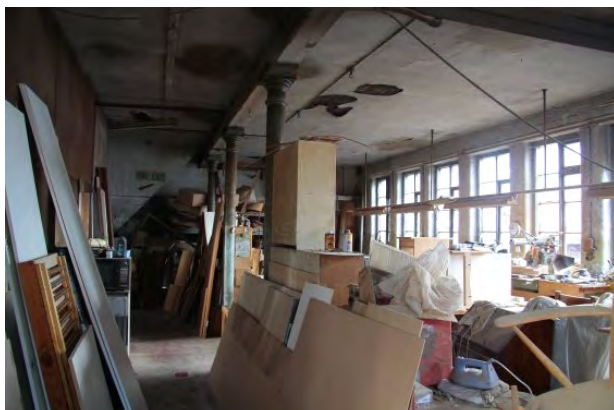
1.26

The space is currently is use a joiners workshop with work benches, materials and power tools throughout. Window and skylight maintenance is likely required due to water ingress, but little other immediate management is needed.

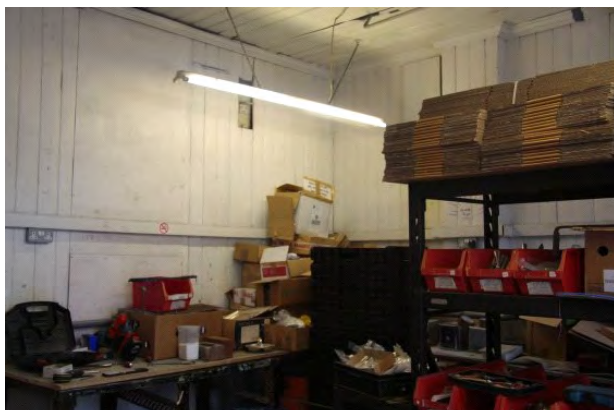
1.29

The room is currently used as a store. The matchboarding needs to be maintained and replaced with suitable material in honest repairs.

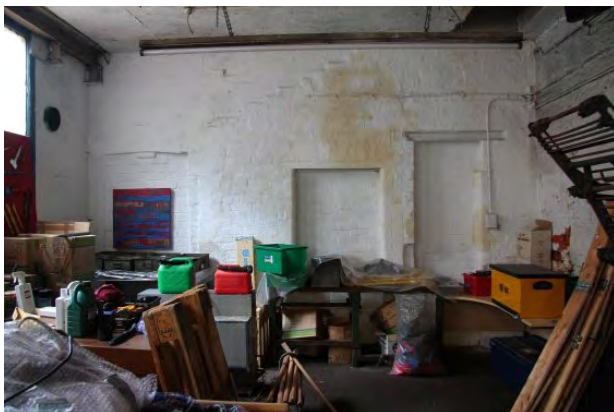
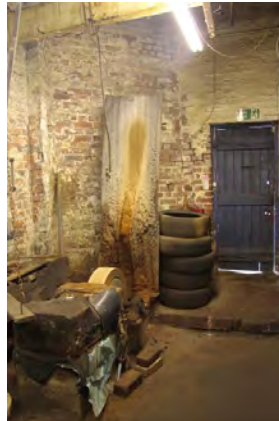
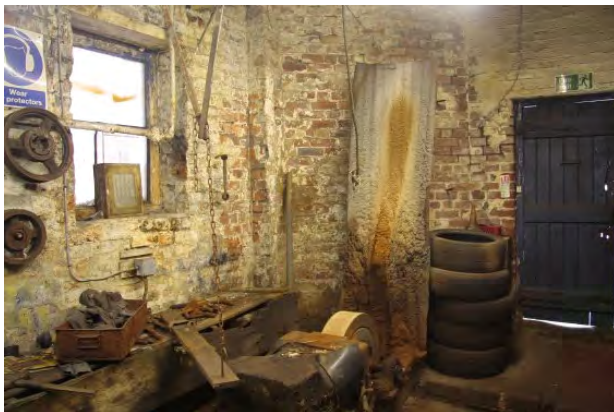
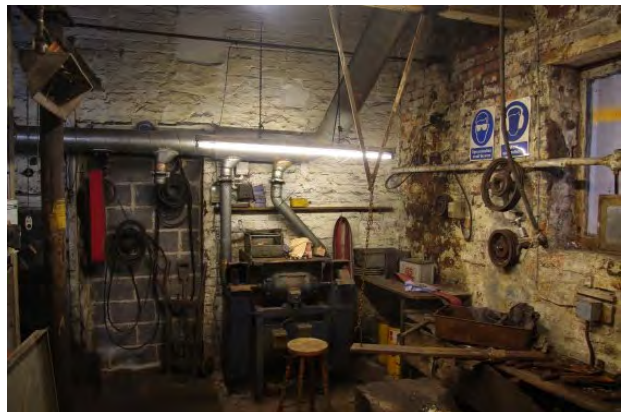
The ceiling is painted shuttered concrete with four former skylights. Water ingress was observed especially around the former skylights.

The space is currently used as a workshop and store. There are few fixtures and fittings which need managing, other than the grinding trough, although secondary. The main priority would be the management of water ingress from the roof and skylights.

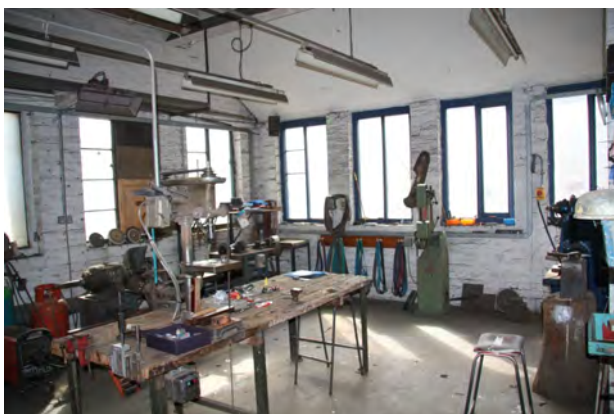
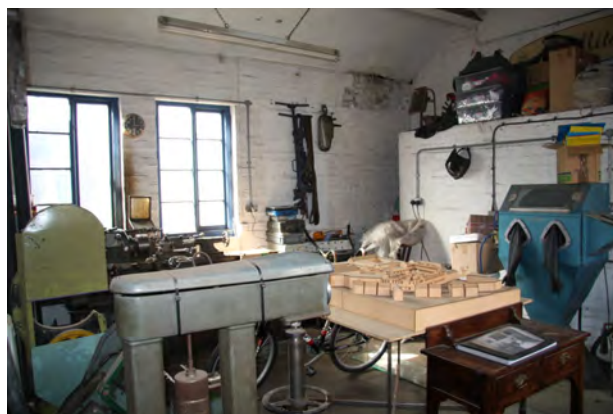
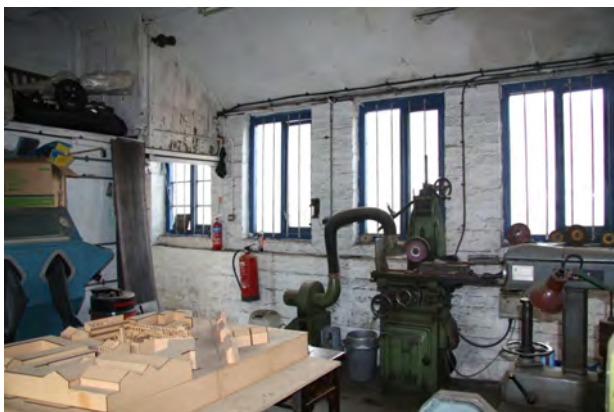
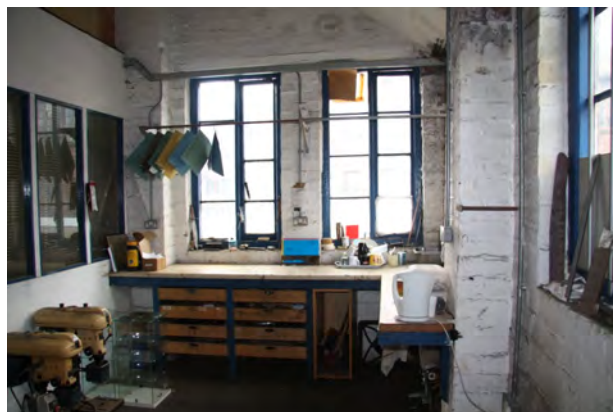
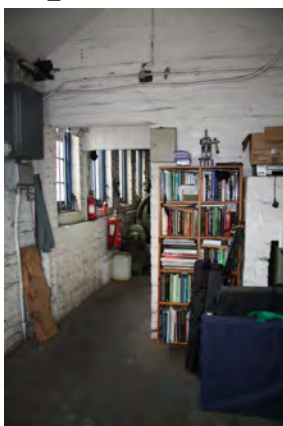
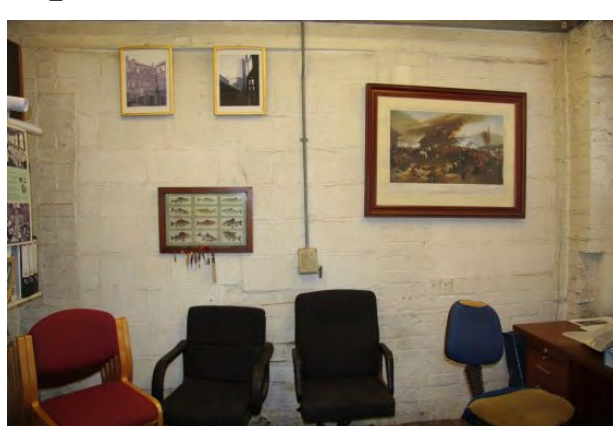
Block G - First Floor (28)

The rooms are open to the roof with boarding attached to the underside of the common rafters. Damage due to water ingress was evident.

The rooms are currently used as a knife making working with works office. The roof and fenestration is in need of attention. Very few fixtures and fittings are in need of specific management.
